# Diagonal Wrinkling (Racking) of Membrane Base Flashing

December 2008

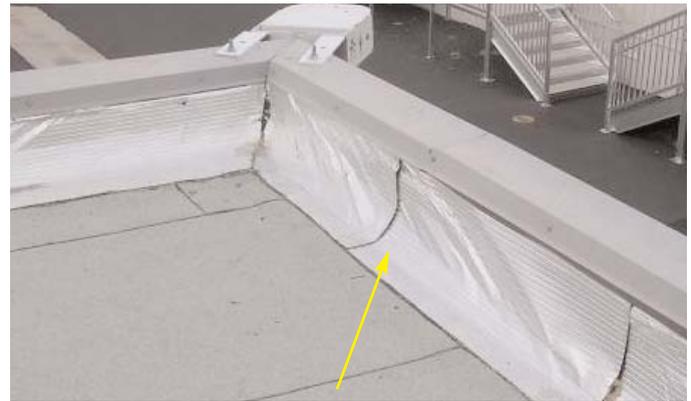
Veral Flashing

All roofing materials used for flashing walls adjoining the roof system can be affected by this type of differential building movement. Veral membrane flashing is no exception. The wrinkles can vary from small to large enough to pull the flashing membrane from the wall, open laps, and delaminate surfacings. Clearly, the roof/flashing membrane should be repaired when the materials are stressed to the point that the watertight integrity of the roof system could be compromised. Membrane damage caused by structural movement and movement of substrate components is typically not covered by membrane manufacturers' guarantees.
